DEPARTMENT OF TRANSPORTATION

Quality Assurance and Source Inspection

Contract #: 04-0120F4Cty: SF/Ala Rte: 80 PM: 13.2/13.9File #: 69.28**WELDING INSPECTION REPORT****Resident Engineer:**Siegenthaler, Peter**Address:** 333 Burma Road**City:** Oakland, CA 94607**Report No:** WIR-021964**Date Inspected:** 28-Feb-2011**Project Name:** SAS Superstructure**OSM Arrival Time:** 1900**Prime Contractor:** American Bridge/Fluor Enterprises, a JV**OSM Departure Time:** 700**Contractor:** Zhenhua Port Machinery Company, Ltd (ZPMC), Changxing Island **Location:** Shanghai, China**CWI Name:** See below**CWI Present:** Yes No**Inspected CWI report:** Yes No N/A**Rod Oven in Use:** Yes No N/A**Electrode to specification:** Yes No N/A**Weld Procedures Followed:** Yes No N/A**Qualified Welders:** Yes No N/A**Verified Joint Fit-up:** Yes No N/A**Approved Drawings:** Yes No N/A**Approved WPS:** Yes No N/A**Delayed / Cancelled:** Yes No N/A**Bridge No:** 34-0006**Component:** OBG Components**Summary of Items Observed:**

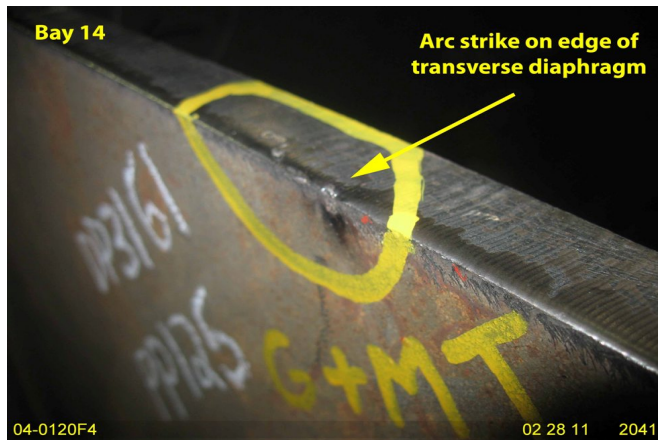
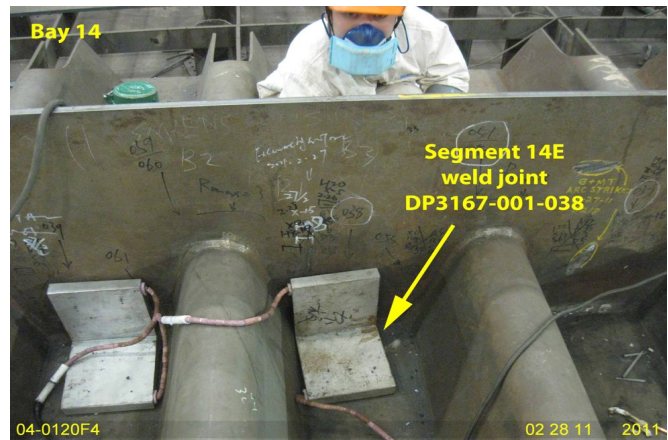
During random observation of the welding operations in Bay 14, several arc strikes were observed on DP3161 and DP3167 deck plates, I-ribs, and transverse diaphragms at and near panel point 125. See photo below of one of the arc strikes. This QA Inspector clearly marked the visual indications in yellow paint with the notation G+MT, signifying 'grind smooth and magnetic particle test' and informed ZPMC QC Zhan Hai Feng (QCA2) of the arc strikes and marking. QCA2 informed this QA Inspector that the arc strikes would be corrected in a manner compliant with the relevant contract documents.
